LAKE CLASSIFICATION SHORT REPORT ON CROOKED LAKE ADAMS COUNTY, WI

Prepared by Reesa Evans, Lake Specialist, CLM Adams County Land & Water Conservation Department P.O. Box 287, Friendship, WI 53934

AUGUST 2007

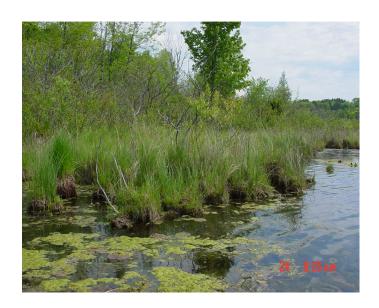
There are several wetlands around the shores of Crooked Lake. Wetlands play an important role in water quality by trapping many pollutants in runoff waters and by serving as buffers to catch and control what would otherwise be uncontrolled water and pollutants. Wetlands also play an essential role in the aquatic food chain, thus affecting fishery, and also serve as spaces for wildlife habitat, wildlife reproduction & nesting, and wildlife food. There are several wetlands at or near Crooked Lake's shore. It is essential to preserve these wetlands for the continued health of Crooked Lake waters.

Wetlands on the shore of Crooked Lake

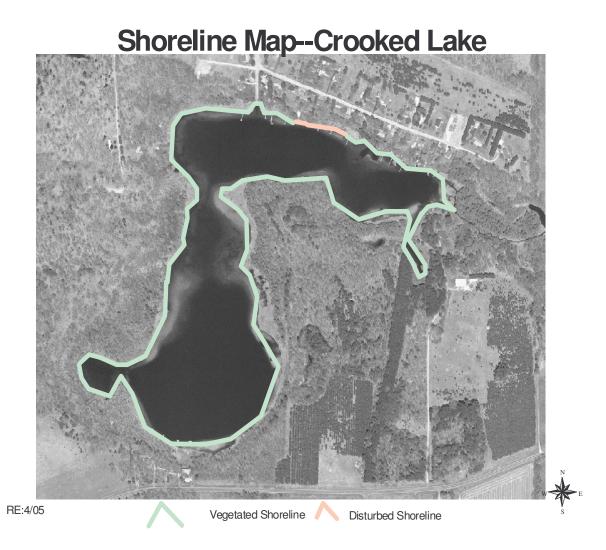
93% of Crooked Lake's shoreline is naturally vegetated. The remaining 6% is mowed lawn.

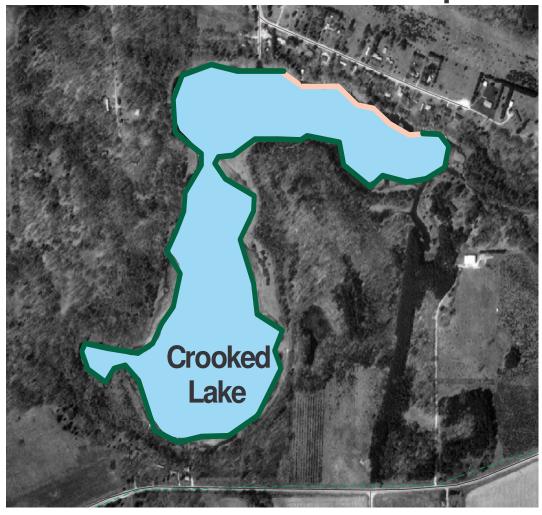
Crooked Lake--Buffer Map

A 2004 shore survey showed that a most of the shore had an "adequate buffer." An "adequate buffer is as a native vegetation strip at least 35 feet landward from the shore. However, parts of the north shore had an inadequate buffer. Most of the "inadequate" buffer areas were those with mowed lawns and insufficient native vegetation at the shoreline to cover 35 feet landward from the water line.

- Shores with inadequate buffers need to restore the buffers to an adequate condition to provide winter habitat for these weevils, as well to assist in maintaining water quality.

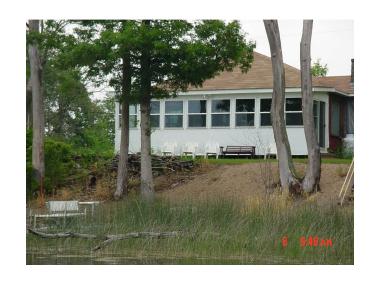
Example of Inadequate Buffer

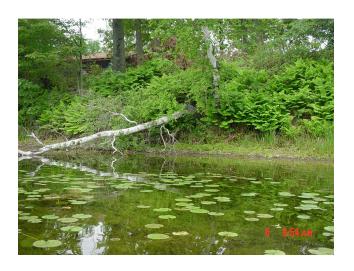
Example of Adequate Buffer

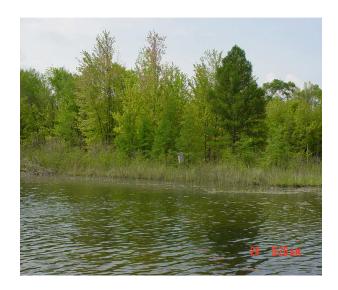
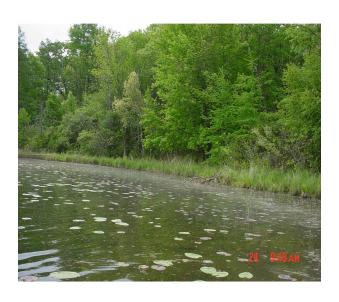
Part of CL1 Part of CL2

Three areas on Crooked Lake were determined to be appropriate for critical habitat designation. CR1 extends along approximately 4200 feet of the southwest shoreline of Crooked Lake, up to the ordinary high water mark. A threatened species of aquatic emergents was found in CL1. CL2 extends along approximately 2900 feet of the southeast shoreline. CL3 covers about 3300 feet of the northern and western shore.
